2020-6784 Drawing 9pcs. 6Cam+HD MDVR 4+1ch + 7inch HD monitor, Volvo Norway, Trønderbilene V1

Project: 2020-6784	Title: System drawing
Bus Manufacture: Volvo	  Agern Allé 24, DK-2970 Hørsholm, Denmark Phone: +45 88910100, Fax: 88910199 E-mail: skantech@skantech.eu, www.skantech.eu
Customer: Volvo Norway	
Ref.:	
Rev.: V1	
Date: 15-10-2020	Init.: LTJ
	Size: A3

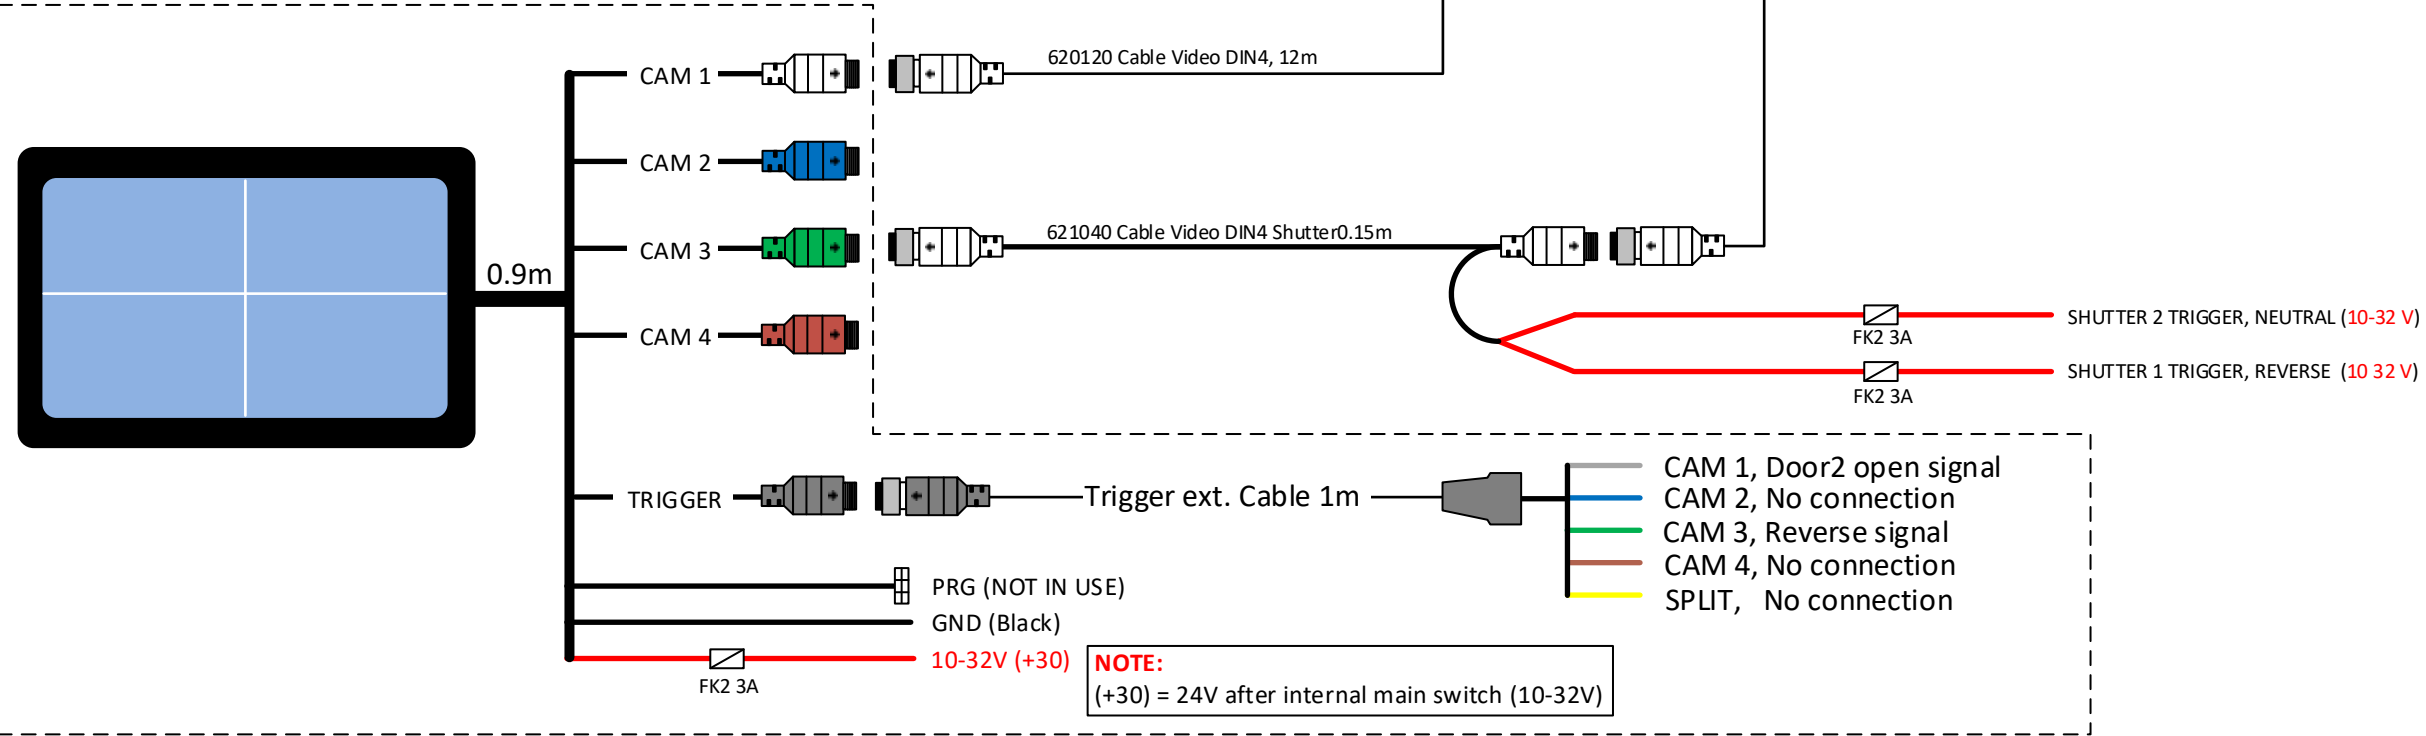
HDMA.2070A HD Monitor

**Note for reverse camera:**  
Both triggers are connected to the same pin in DIN4 connector. This can trigger a circuit brake, if one is connected to ground.

4CH TRIGGER PRIORITY	Split	Cam4	Cam3	Cam2	Cam1	VIEW
"0" = signal pin is low	X	X	1	X	X	C3
"1" = signal pin is high	0	0	0	0	1	C1
"X" = signal does not matter	0	0	0	1	0	C2
	0	X	0	1	1	C1 C2
	0	1	0	0	0	C4
Signal levels:	1	X	0	X	X	C1 C2 C3 C4
"0" = 0-2V (GND)	0	1	0	0	1	C1 C4
"1" = 10 -> 32V	0	1	0	1	0	C2 C4
	0	0	0	0	0	Blank Black
